Forensic Building Science, Inc.
657 Lincoln Avenue
St. Paul, MN 55105
T: 651.222.6509
www.forensicbuildingscience.com

Date: January 19, 2018

Property: Rocky Waters Motel, Inc. (Days Inn Gatlinburg on the River)
324 Hemlock Street
Gatlinburg, TN 37738

Photo Log – January 4, 2018

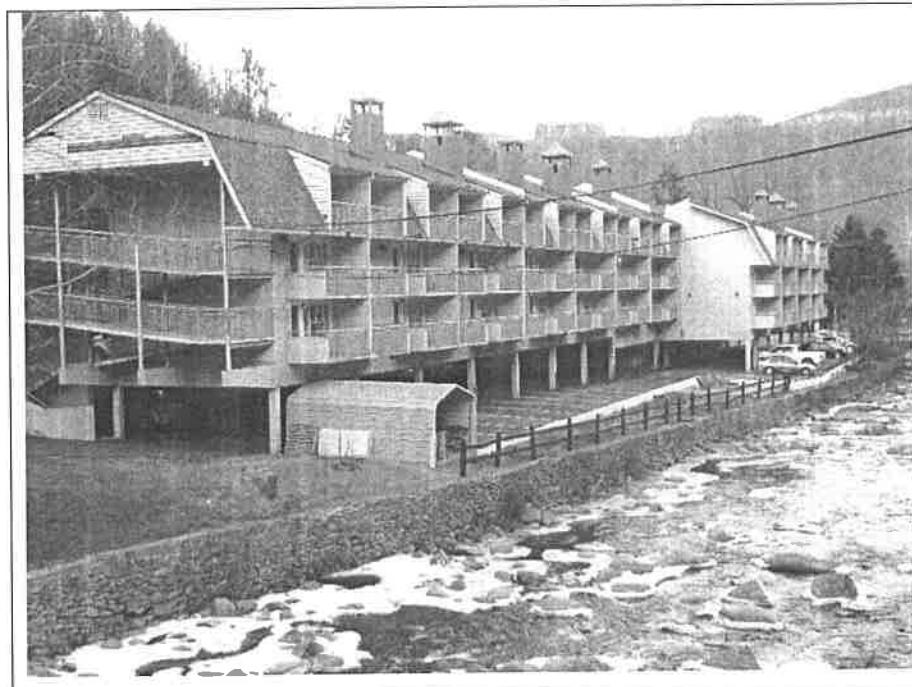
Figure 04. Back elevation. (AP)

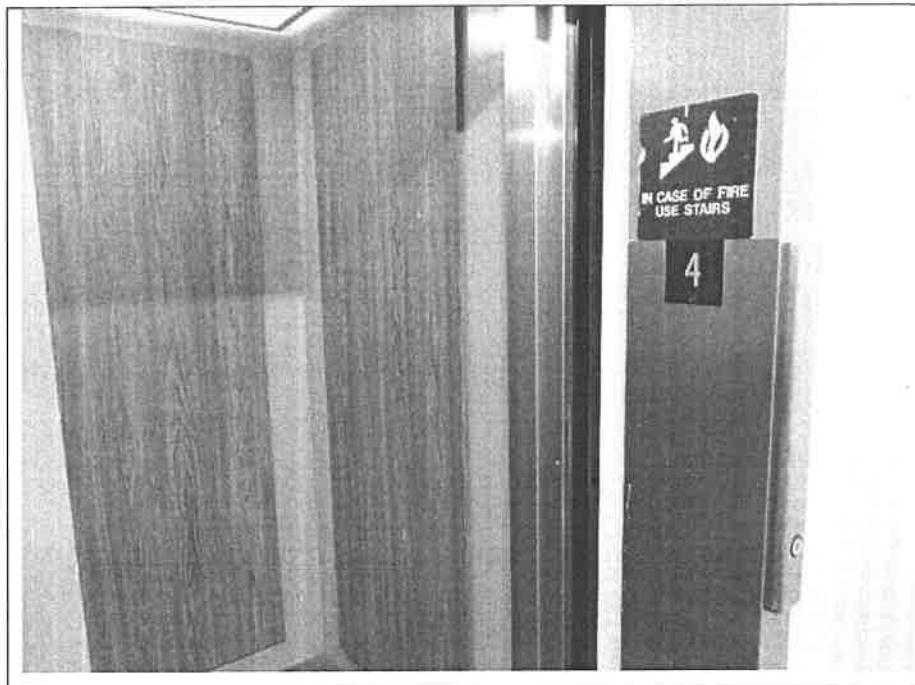
Figure 116. 4th floor elevator. (AP)
